Airbus 380 flips CL604 - full report is now published

- **Interim report finally released by the German BFU**
- **Flight Service Bureau version of events confirmed**
- **New pictures released by the investigators**

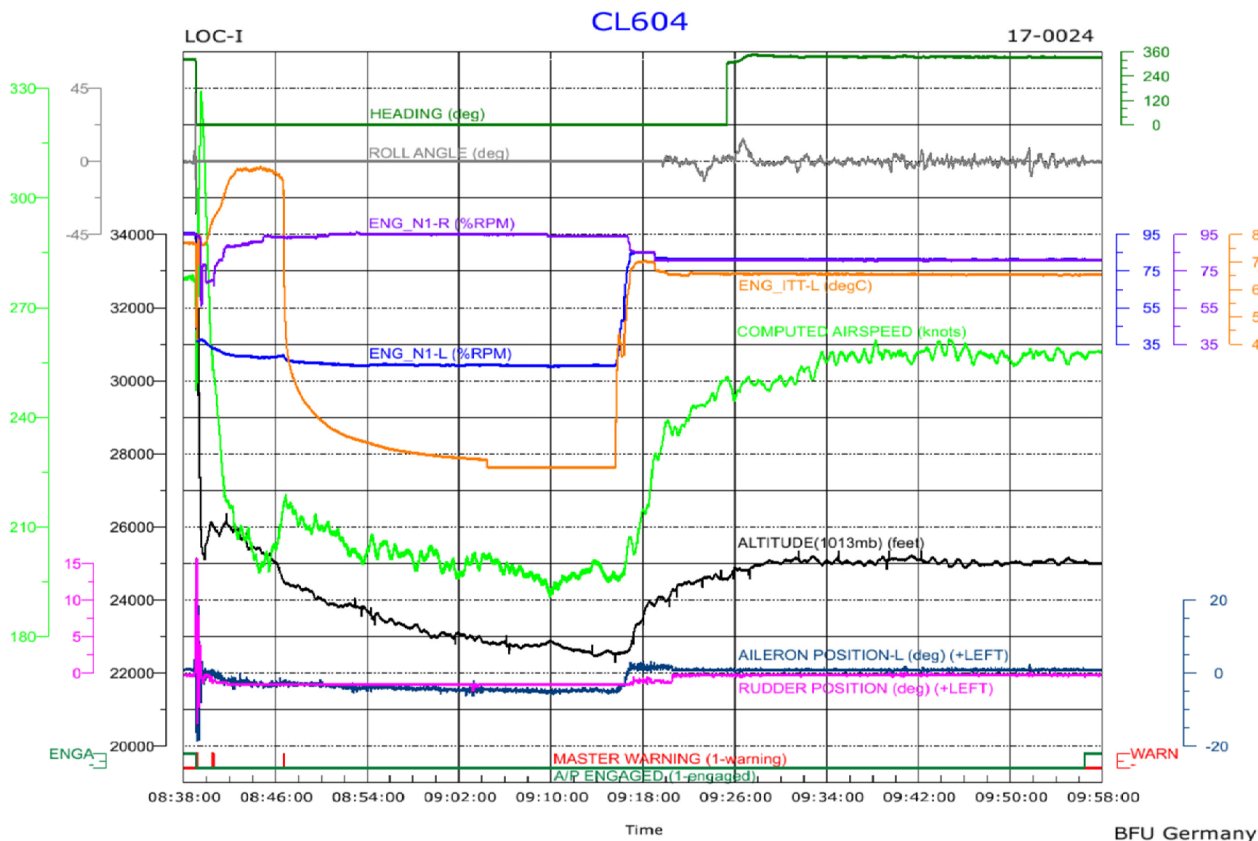
- The incident was caused by the wake from an Airbus A380 at FL350
- The Challenger 604 passed directly underneath the A380 at FL340
- The wake encounter occurred **48 seconds** after the cross - when the two aircraft were 15nm part
- The Challenger initially rolled 42 degrees to the right, then 31 degrees left, and experienced G-Loads of 1.6g positive followed 1 second later by -3.2 g.
- It lost altitude from FL340 to FL253 over a 2 minute period - loss of 8700 ft.

The BFU published the FDR excerpt above, and a full interior picture of the cabin, post event.

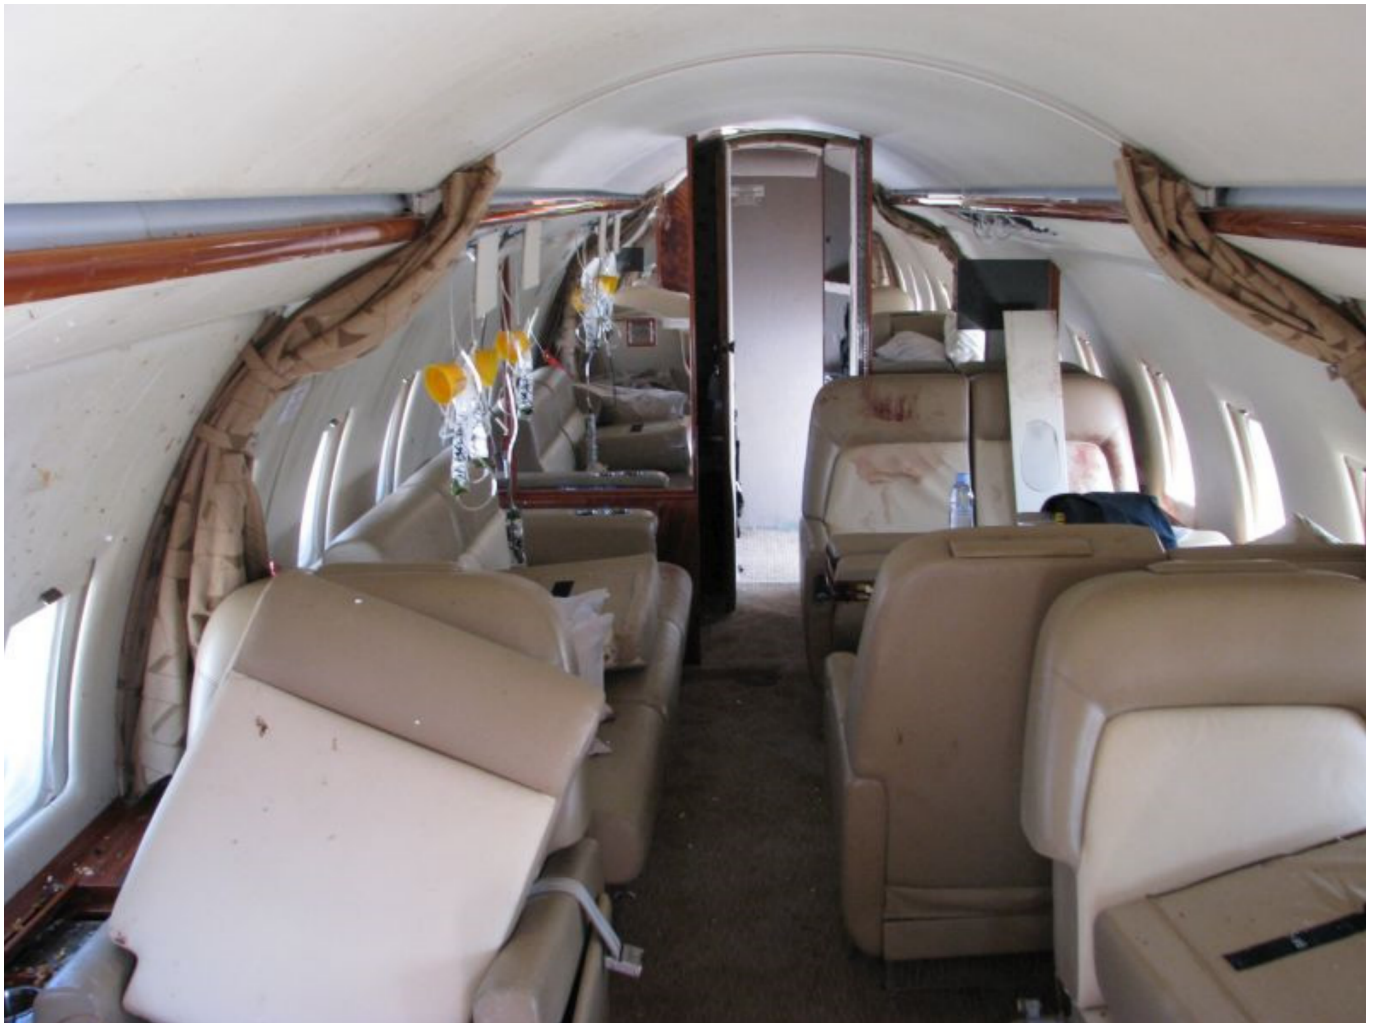
[We] actuated the aileron to the right in order to stop the rolling motion. But the airplane had continued to roll to the left thereby completing several rotations. Subsequently both Inertial Reference Systems (IRS), the Flight Management System (FMS), and the attitude indication failed”

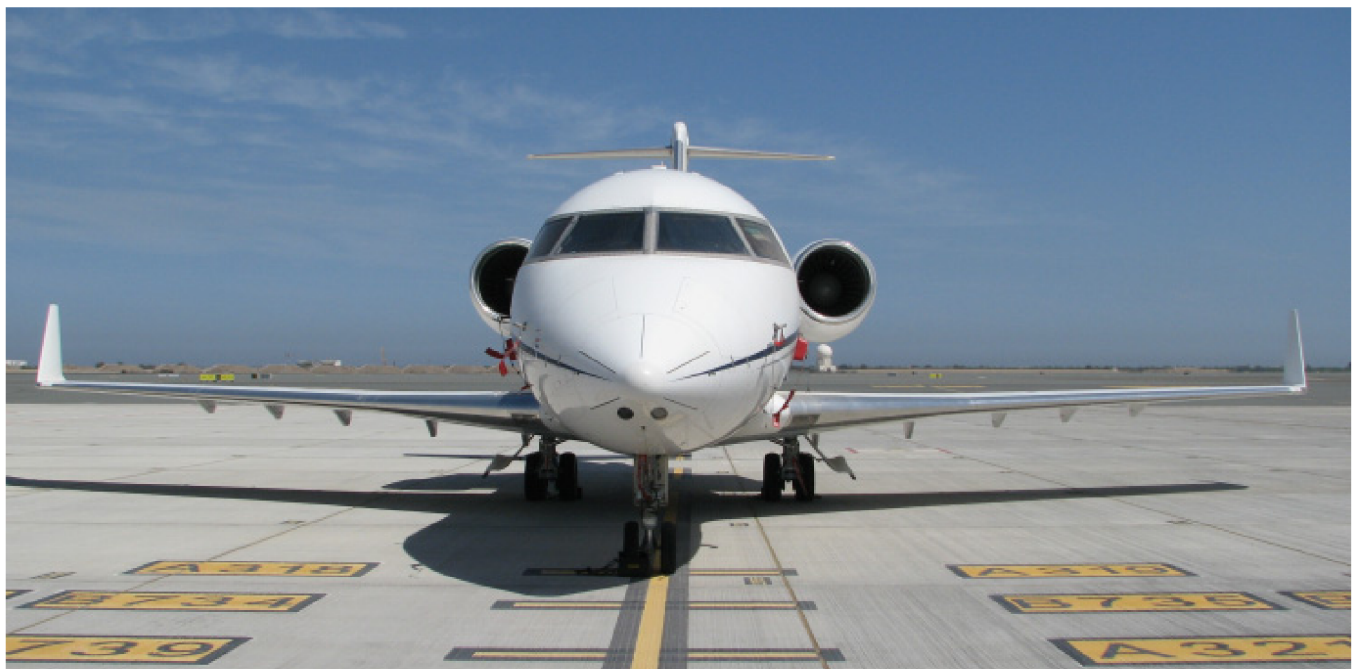
Source: BFU

Outer condition of the airplane
