Airbus 380 flips CL604 - full report is now published

- **Interim report finally released by the German BFU**
- **Flight Service Bureau version of events confirmed**
- **New pictures released by the investigators**

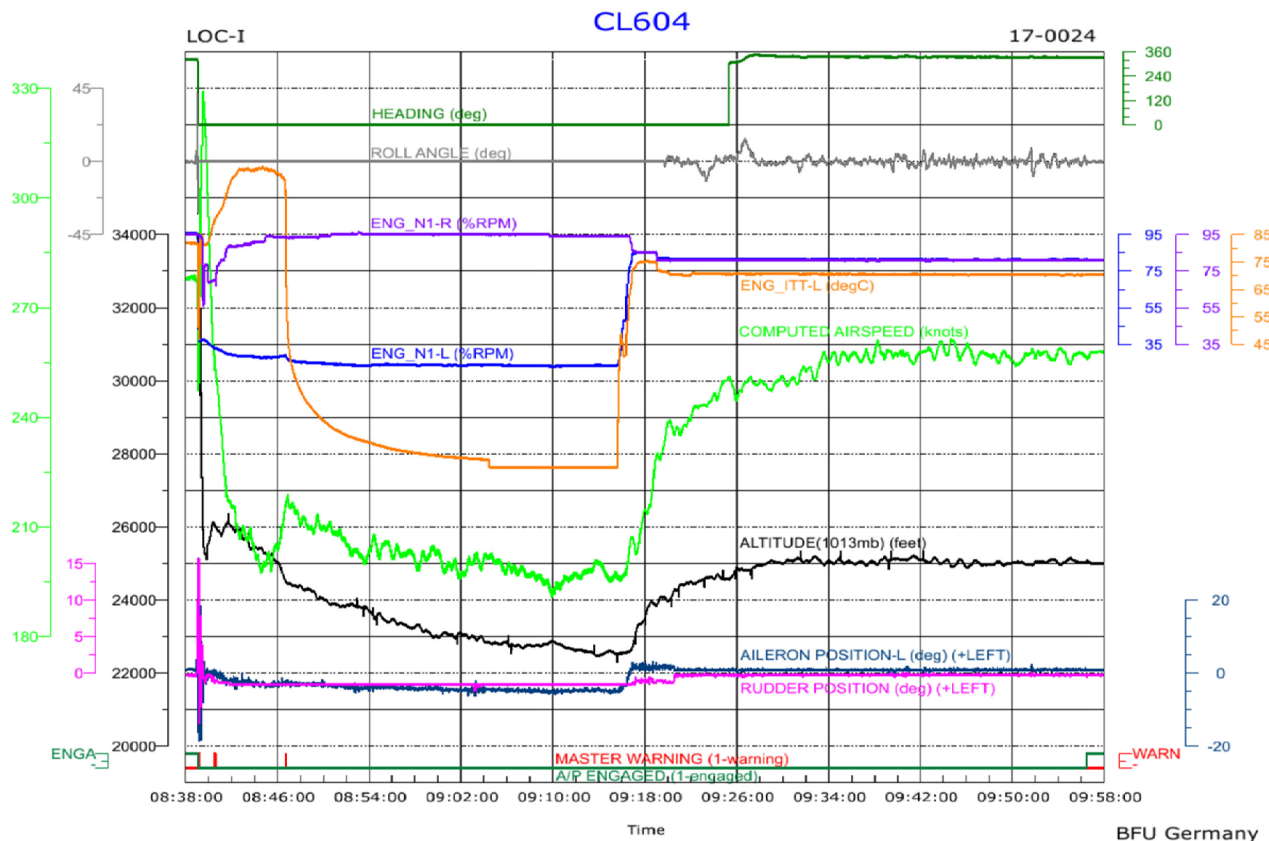
- The incident was caused by the wake from an Airbus A380 at FL350
- The Challenger 604 passed directly underneath the A380 at FL340
- The wake encounter occurred **48 seconds** after the cross - when the two aircraft were 15nm part
- The Challenger initially rolled 42 degrees to the right, then 31 degrees left, and experienced G-Loads of 1.6g positive followed 1 second later by -3.2 g.
- It lost altitude from FL340 to FL253 over a 2 minute period - loss of 8700 ft.

The BFU published the FDR excerpt above, and a full interior picture of the cabin, post event.
