# CPDLC Gotcha: Clearance Busts

Chris Shieff

29 August, 2023

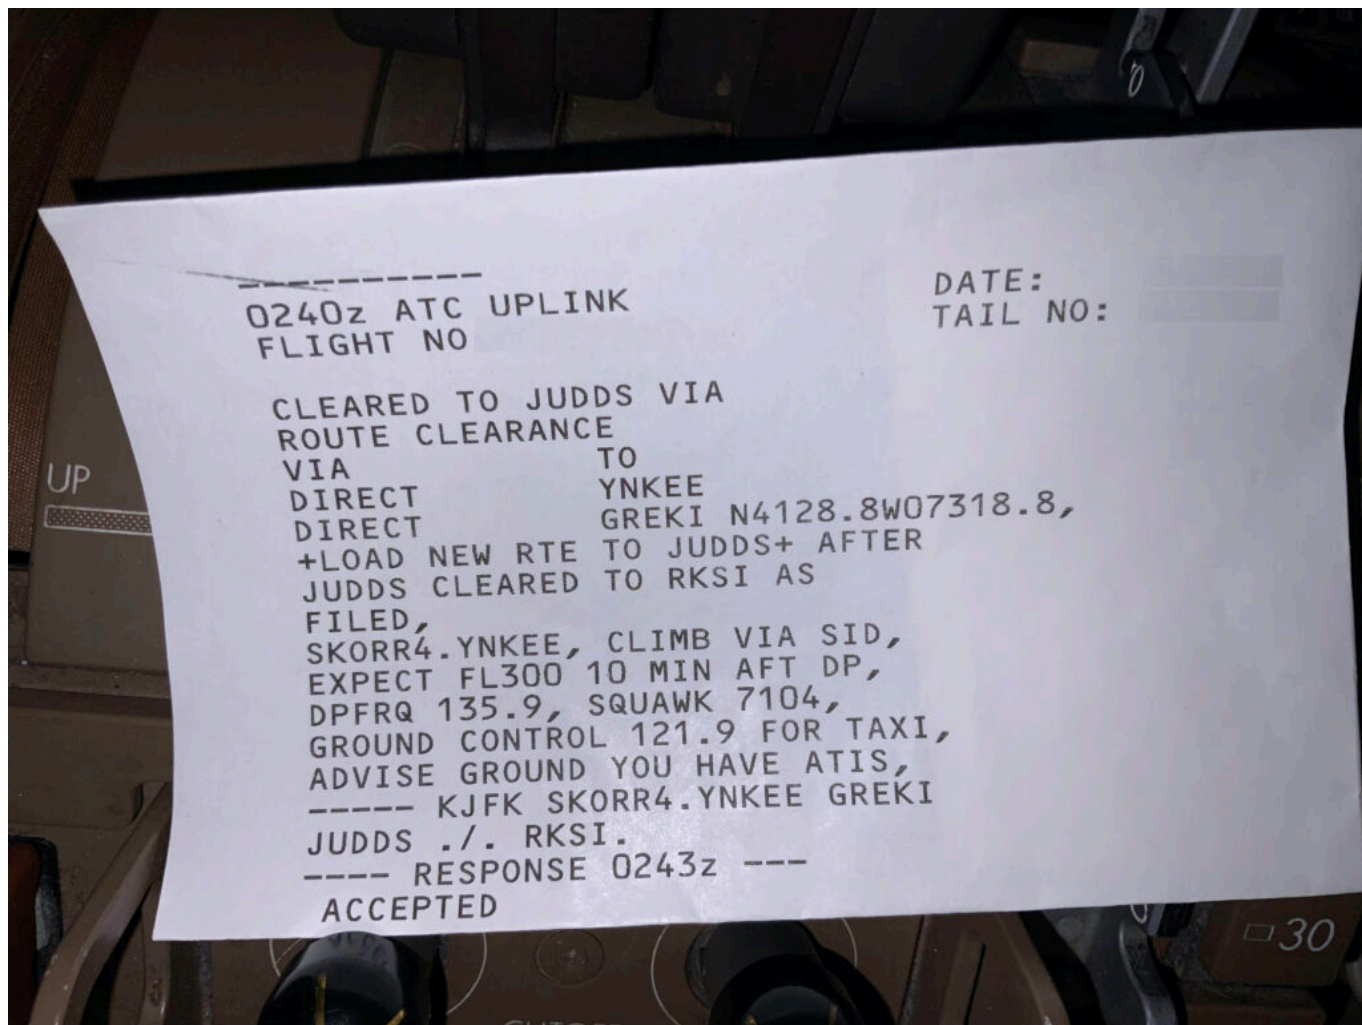
**A change to a clearance** was received by a B777 at **KJFK/New York** during taxi and under considerable pressure to get *underway or out of the way*:

Unfortunately, in this instance the crew **mis-interpreted their clearance as direct to the waypoint YNKEE**. This was further compounded by the issue above – when the new route was loaded, **their SID was dropped from the flight plan**.

When they got airborne, ATC immediately began asking why they weren't following the assigned SID – the result was a **clearance bust**. To their surprise, further down the clearance was indeed an assigned SID – the SKORR4. It was an understandable and easy miss.

It maybe comes down to a machine readability issue. The section above the plus signs is required because of the way the clearance is written, and is related to the same issues as above. **It will not contain a SID when you insert it.**

In fact, some newer CPDLC systems don't even show that section to the crew – only the information below the plus signs which contains the assigned SID. The full version is a **confusing**, and seemingly **contradictory** set up.
