CPDLC Gotcha: Clearance Busts

Chris Shieff

29 August, 2023

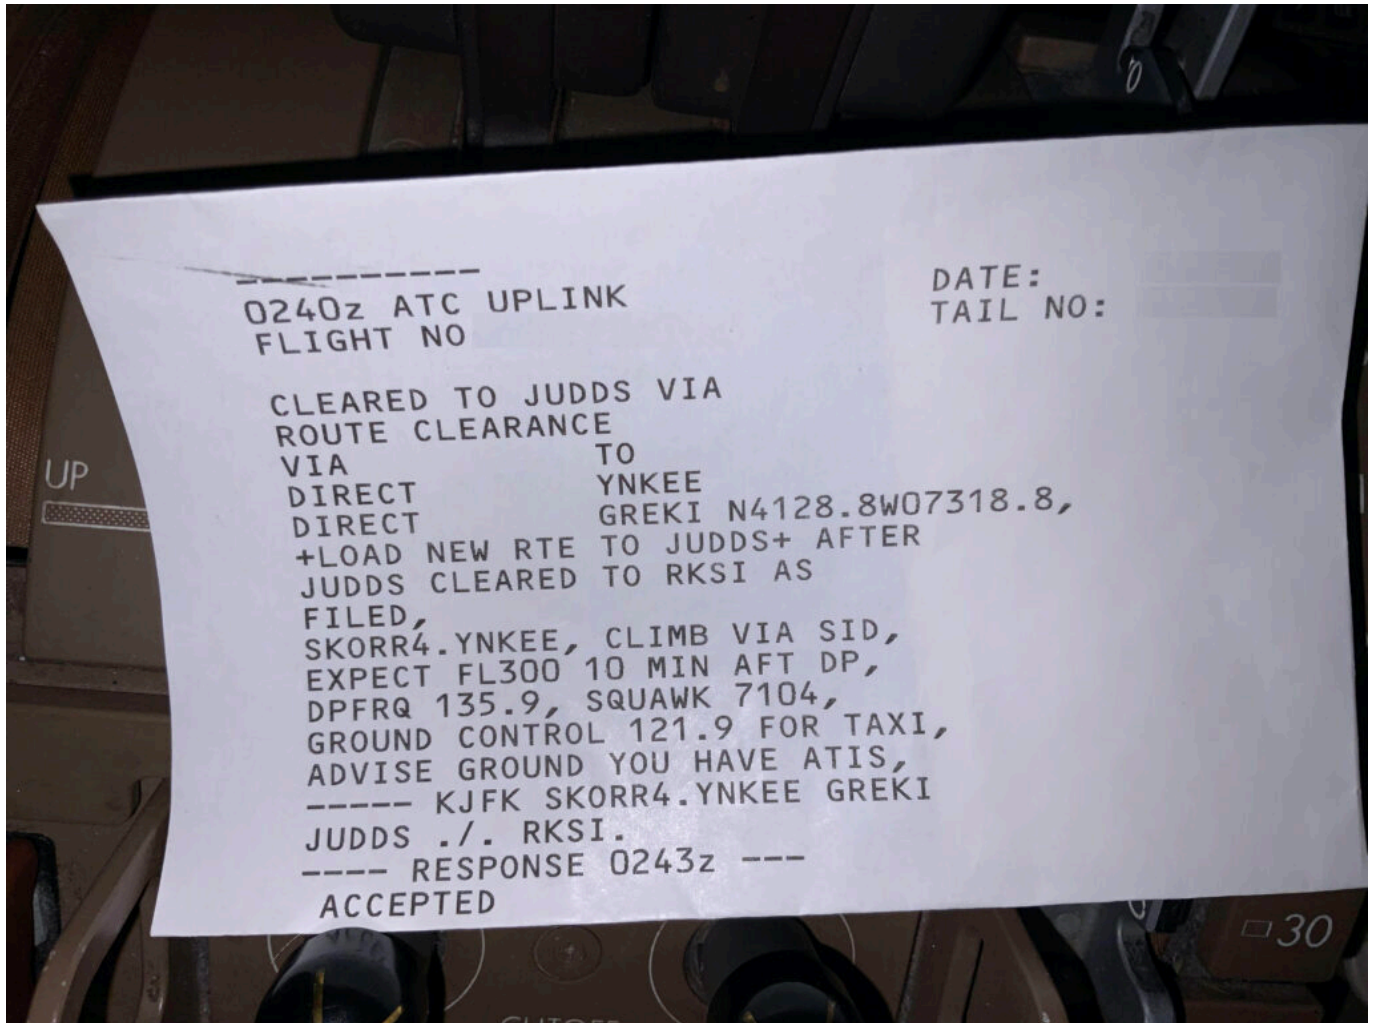
A change to a clearance was received by a B777 at **KJFK/New York** during taxi and under considerable pressure to get *underway or out of the way*:

Unfortunately, in this instance the crew **mis-interpreted their clearance as direct to the waypoint YNKEE**. This was further compounded by the issue above - when the new route was loaded, **their SID was dropped from the flight plan**.

When they got airborne, ATC immediately began asking why they weren't following the assigned SID - the result was a **clearance bust**. To their surprise, further down the clearance was indeed an assigned SID - the SKORR4. It was an understandable and easy miss.

It maybe comes down to a machine readability issue. The section above the plus signs is required because of the way the clearance is written, and is related to the same issues as above. **It will not contain a SID when you insert it.**

In fact, some newer CPDLC systems don't even show that section to the crew - only the information below the plus signs which contains the assigned SID. The full version is a **confusing**, and seemingly **contradictory** set up.

- The FAA has published a new Safety Alert for CPDLC and partial route re-clearances.
- Make sure you load your full SID manually into the FMS after you receive a partial reroute message (UM79).
- Also, don't mistake these partial reroute messages as being cleared to fly directly to the waypoint (a direct clearance would be a UM74 message).
