Aviation Investigation Final Report

Location:	Naples, Florida	Accident Number:	ERA24FA110
Date & Time:	February 9, 2024, 15:11 Local	Registration:	N823KD
Aircraft:	BOMBARDIER INC CL-600-2B16	Aircraft Damage:	Destroyed
Defining Event:	Powerplant sys/comp malf/fail	Injuries:	2 Fatal, 4 Minor
Flight Conducted Under:	Part 135: Air taxi & commuter - Non-scheduled

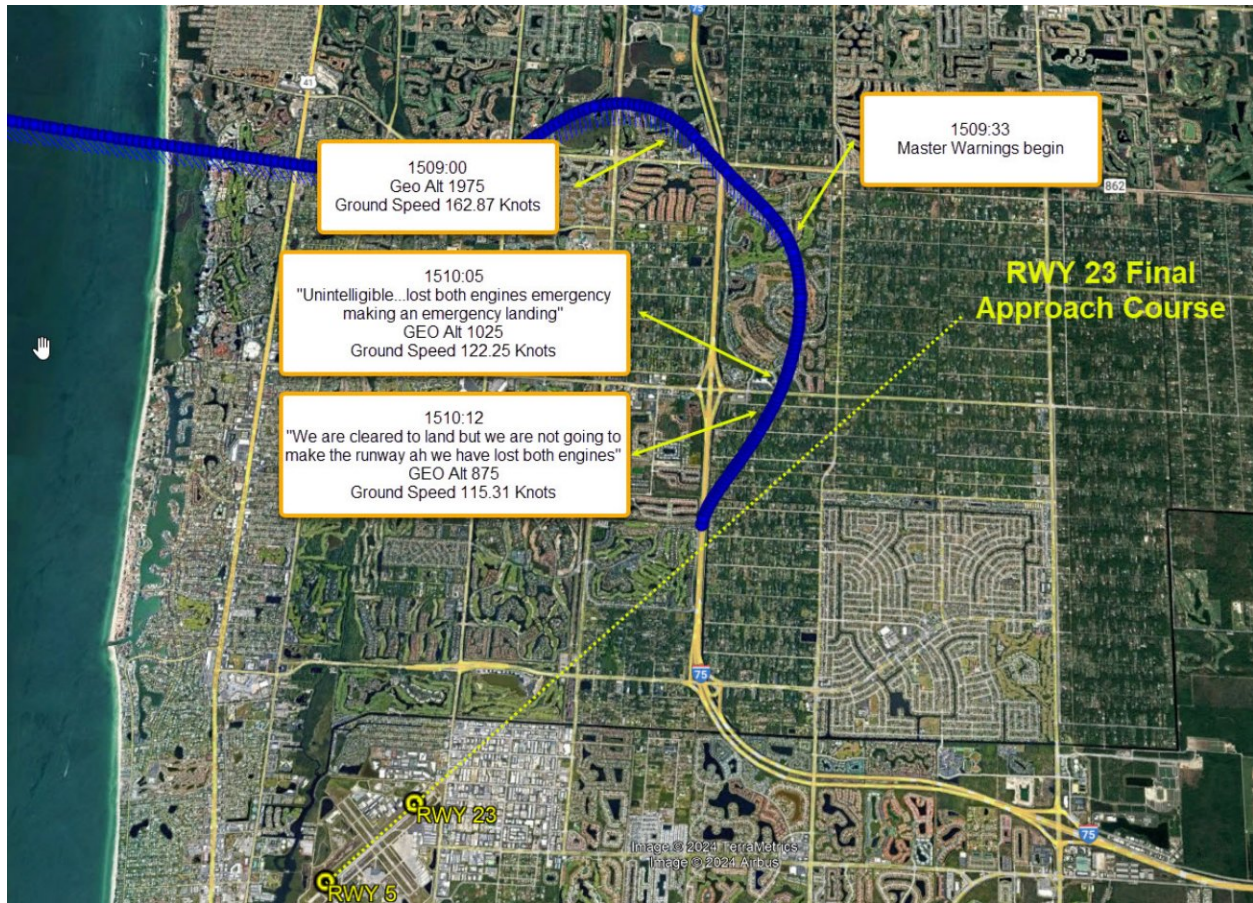
ADS-B flight track data and downloaded cockpit voice recorder (CVR) communications revealed that the flight crew contacted the APF air traffic control tower while on a right downwind leg of the approach to the airport and maneuvering for a 5-mile final approach to runway 23. About 1509, the tower controller cleared the flight to land. The airplane was about 6.5 miles north of APF, about 2,000 ft geometric altitude, and 166 kts ground speed, as it turned onto final approach for runway 23.

Twenty-three seconds later, at 1510:03, about 1,000 ft pressure altitude and 122 kts, on a shallow intercept angle for the final approach course, the crew announced, "...lost both engines... emergency... making an emergency landing" (see figure 1). The tower controller acknowledged the transmission and cleared the airplane to land. At 1510:12, about 900 ft and 115 kts, the crew replied, "eh we're clear to land but we're not gonna make the runway uh we've lost both engines."

Figure 1. ADS-B ground track (blue dots) with annotations of specific events during the approach, including time and the airplane's geometric altitude and ground speed (source: FAA).

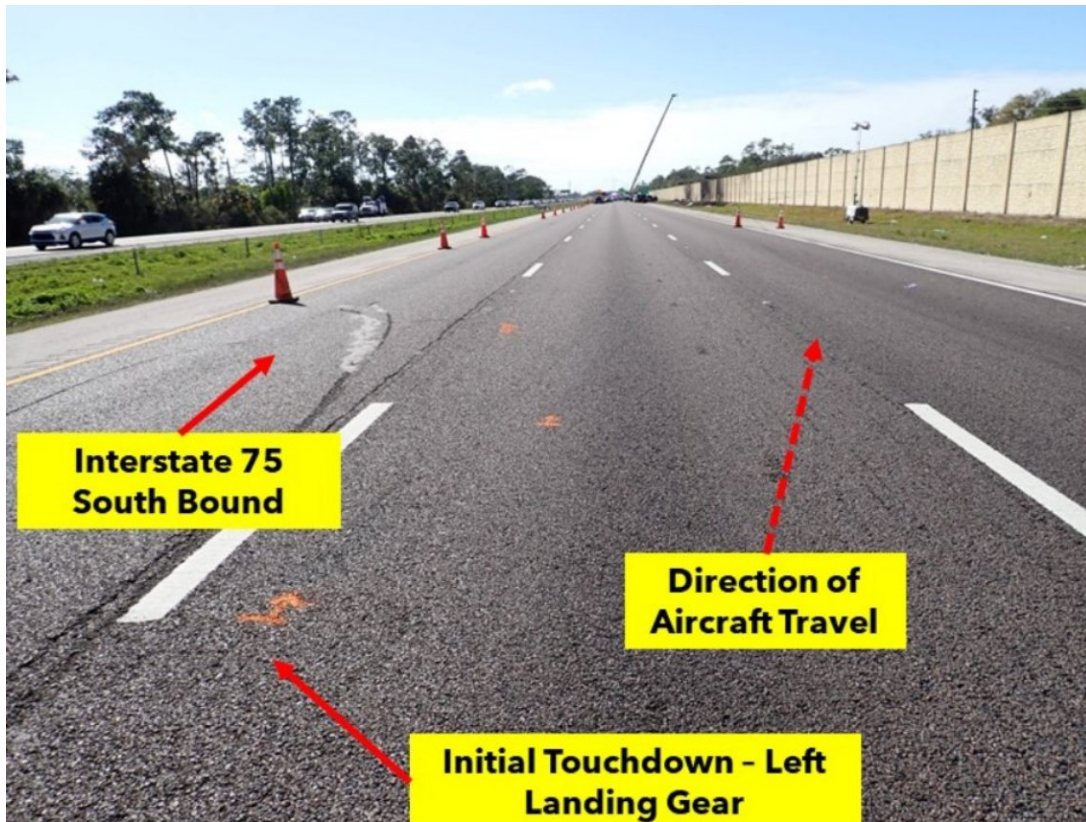
Examination of the accident site revealed tire marks on the southbound lanes of Interstate 75 consistent with the left main landing gear (see figure 2). The airplane came to rest about 1,000 ft past the initial touchdown point, upright in the grass area between the breakdown lane and the sound barrier wall and facing north, opposite the direction of travel.

Figure 2. Initial touchdown point on Interstate 75.

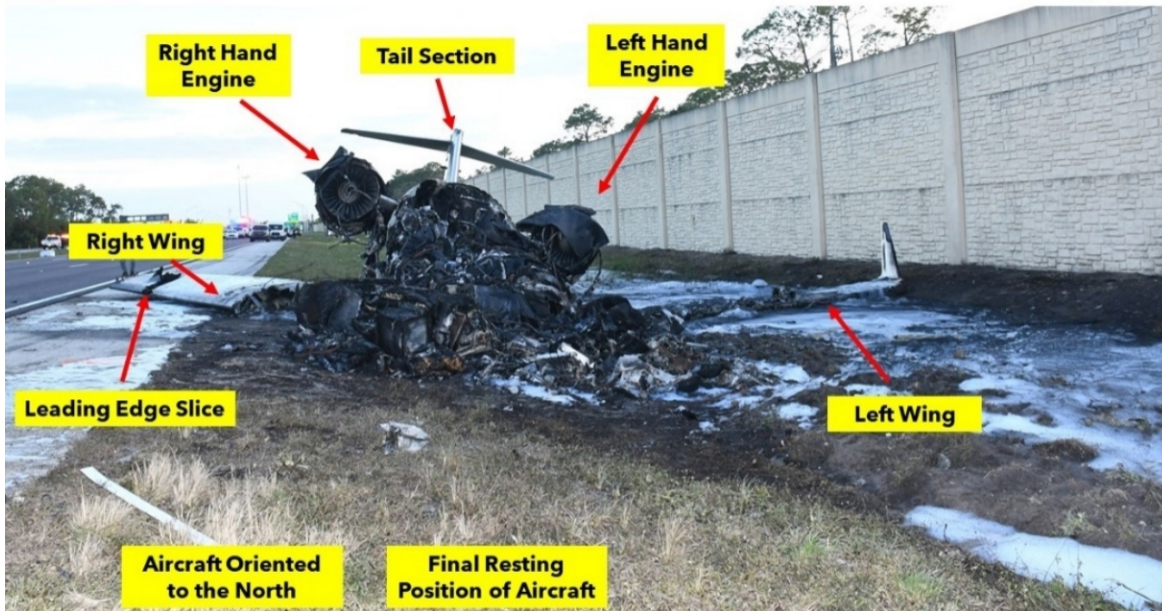
The forward portion of the fuselage was consumed by postimpact fire (see figure 3). All major components of the airplane were accounted for at the scene, and the ground surrounding the wreckage was fuel-soaked, having an odor consistent with Jet A fuel. The cockpit center console was found separated from the main wreckage. Both engine thrust levers were found near the IDLE stop position. The flap selector handle was found in a position consistent with 45° flap extension.

Figure 3. Main wreckage as found.
