Tokyo International Airport Runway Incursion Hazard Map

Tokyo International Airport Runway Safety Team
Ver 2020.11.05

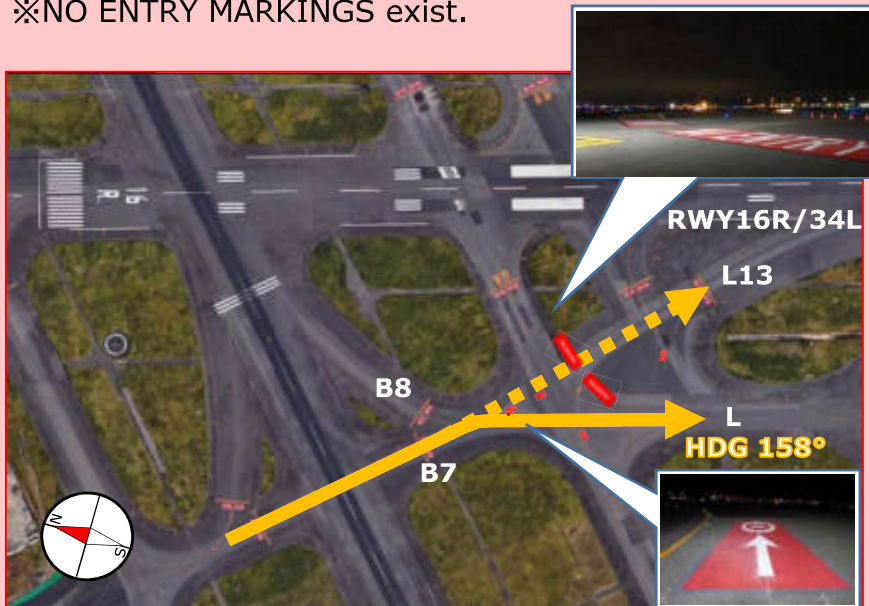
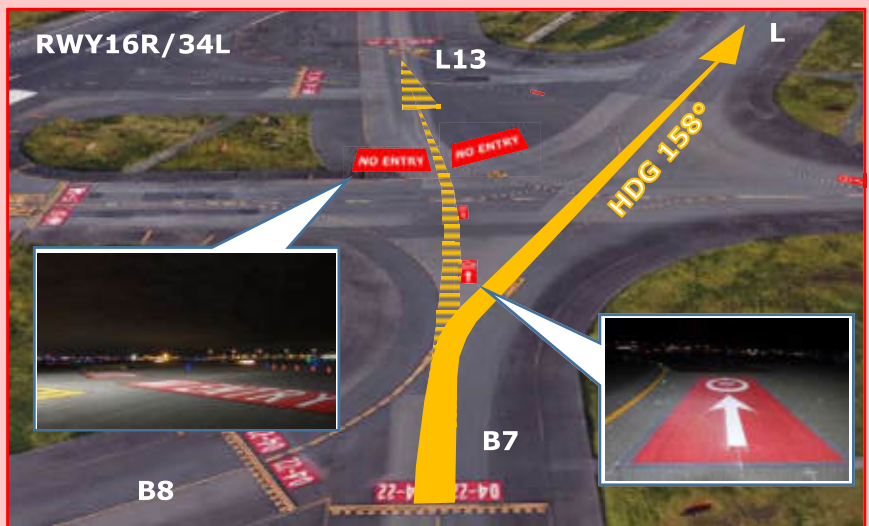
【B7→ L】

Pilots sometimes confuse L-TWY with L13, while taxiing from B7 to L-TWY. Do not enter L13.
※NO ENTRY MARKINGS exist.

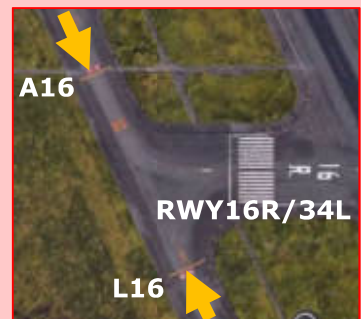
【L16 – RWY16R/34L - A16】
Runway holding position markings are installed. ATC authorization shall be required for crossing the runway.

【T11 → A16】
Slope inclined downward toward RWY16R/34L. (①)
【T11 → RWY04/22 → B10】
Right turn while crossing RWY04/22. (②)

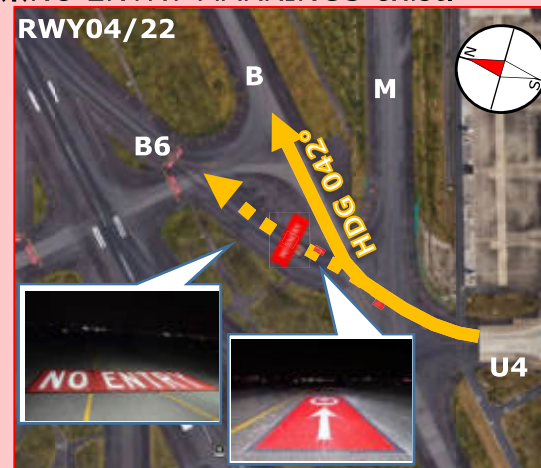
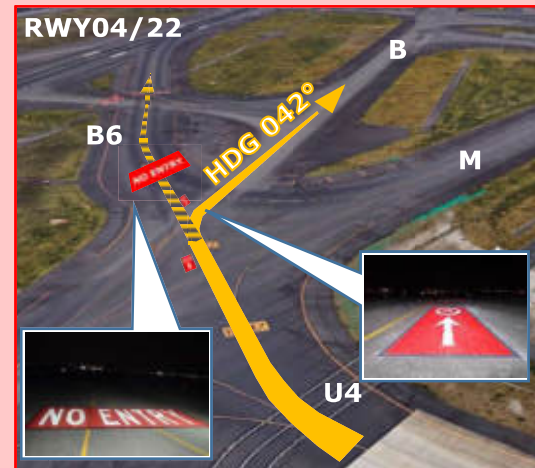
【U4 → B-TWY】

Pilots sometimes confuse B-TWY with B6, while taxiing from U4 to B-TWY. Do not enter B6.
※NO ENTRY MARKINGS exist.

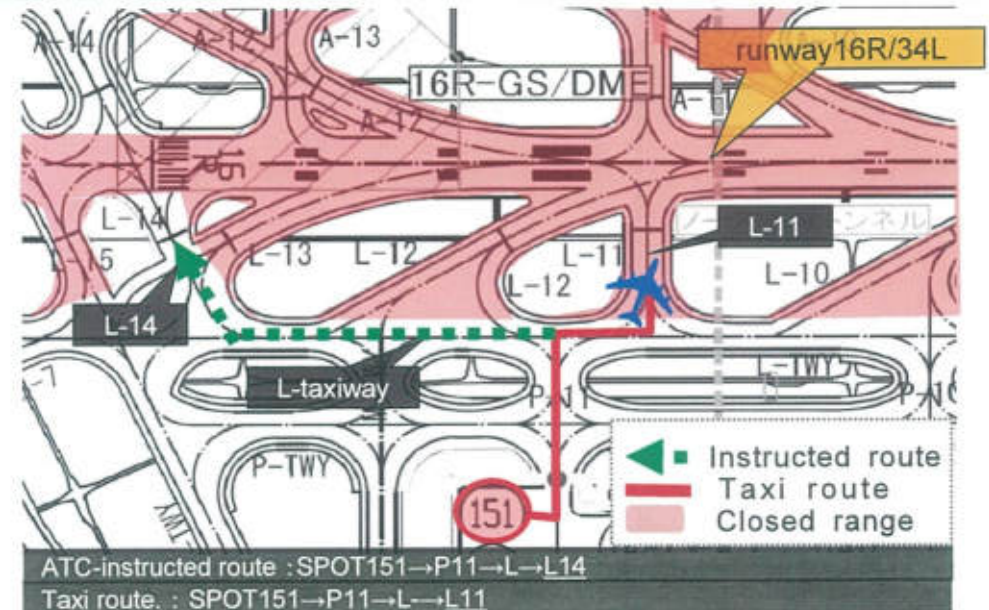
【 An incident in which an aircraft mistakenly entered a closed taxiway 】 September 2021

The aircraft in question was instructed to taxi via P11→L→L14 from spot 151 by the controller and repeated the instructions correctly, but turned right from P11 into the L taxiway, then turned left and entered L11. The controller noticed that the aircraft in question was proceeding on the wrong route and instructed the aircraft to stop at its current location. The flight information officer conducted a temporary inspection and confirmed that there was no abnormality, so the flight information officer led the aircraft to runway 16L by the officer's vehicle and the aircraft took off from runway 16L.

- It was the first time for the crew in question to operate at this airport.
- They were concentrating on the checklist while taxiing, and misunderstood ATC instructions as “P11→L→L11”.
- There was no confirmation among the crew as to whether the route after P11 was a left turn or right turn.

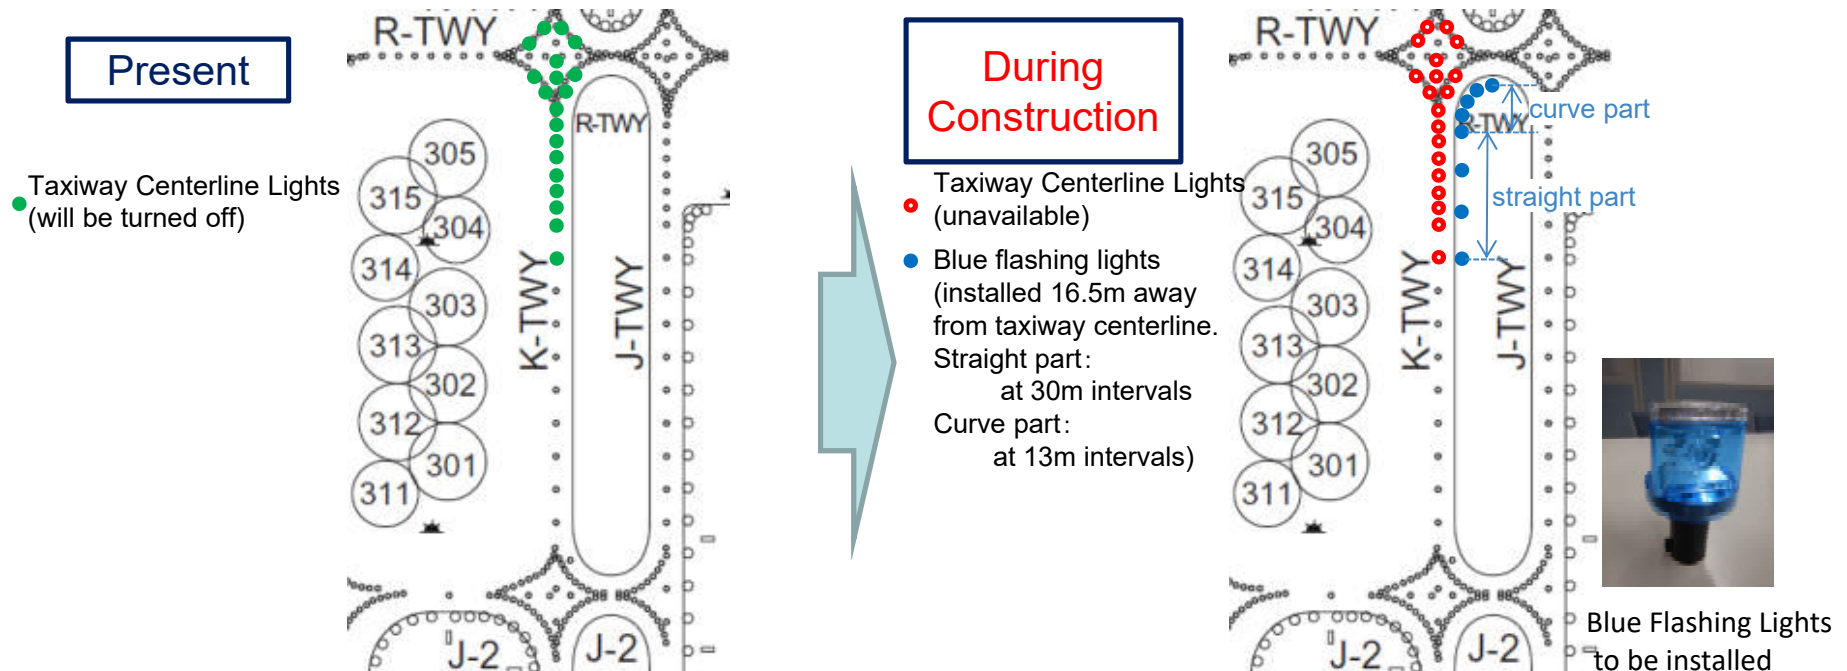
Installation of Flashing-lights for K-TWY in Tokyo INTL AP

- Due to pavement construction for K-TWY, Taxiway Centerline Lights(TCLL) of K-TWY between R and J2 will be unavailable, from Dec 1st 2022 to Mar 31st 2023.
- Blue flashing lights will be installed as taxiway guidance marks, while TCLL is unavailable.
- Be aware that blue flashing lights are not TCLL.

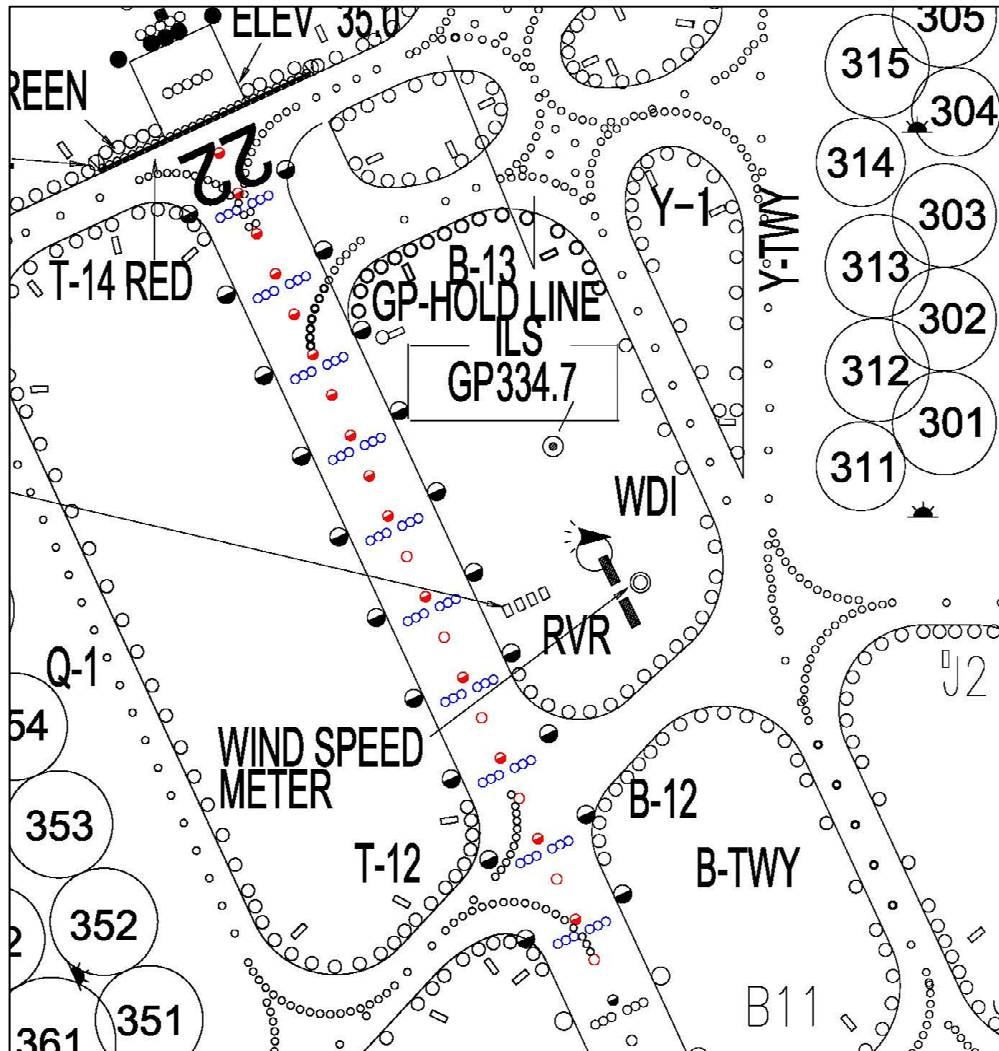
Unlit RW22 Runway Lighting (RJTT)

Unlit Runway Centerline Lights
-

Unlit Runway Touchdown Zone Lights

Unlit Period
0600 Japan Standard Time
01FEB2022 to late March 2023

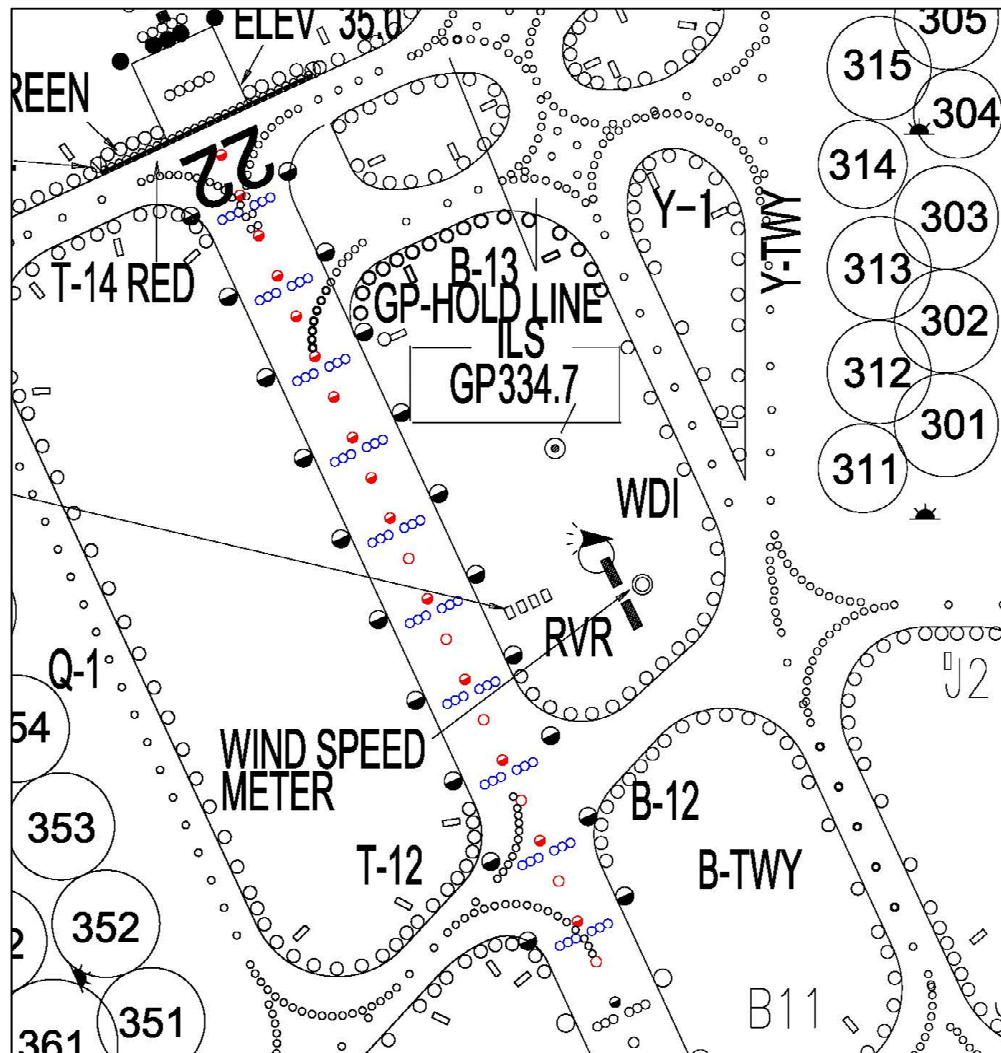
Unserviceable LGT on RWY.04/22 at Tokyo INTL AP/RJTT

Unserviceable LGTs

Runway center line lights
(see RJTT NOTAM)
-

Runway touchdown
zone lights
(see RJTT NOTAM)

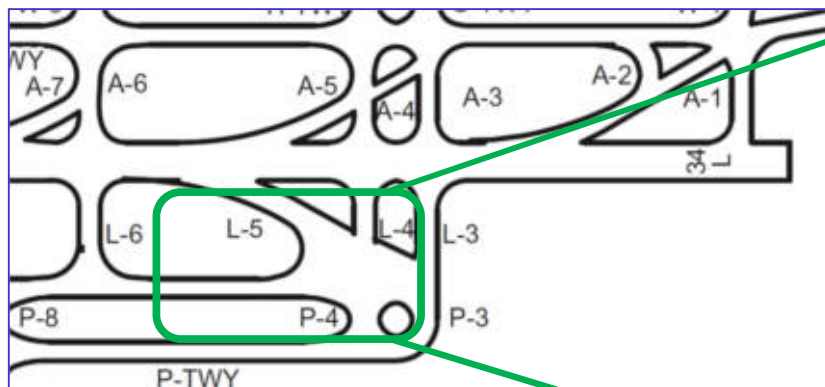
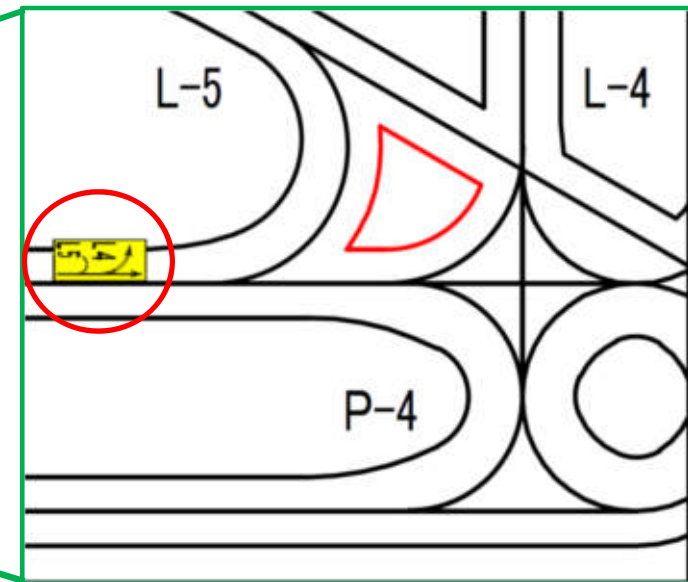
Surface Painted Markings on L-TWY in Tokyo INTL AP

Surface Painted Markings as follow will be installed on L-TWY so as not to enter the L5-TWY by mistake.
