# CPDLC Gotcha: Clearance Busts

Chris Shieff

29 August, 2023

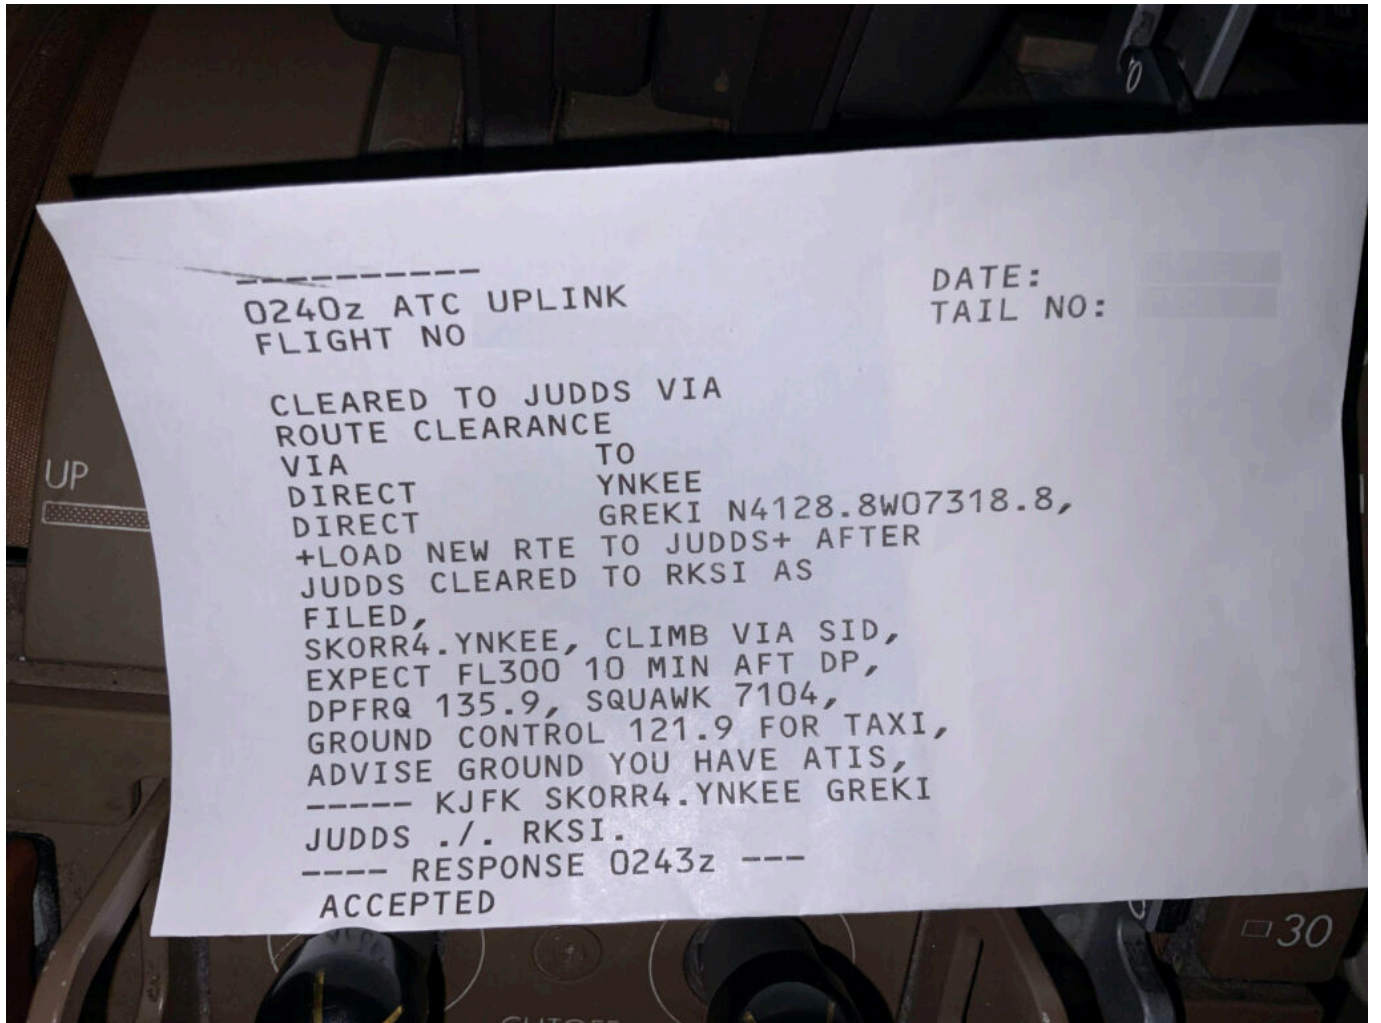
**A change to a clearance** was received by a B777 at **KJFK/New York** during taxi and under considerable pressure to get *underway or out of the way*:

CLEARED TO JUDDS VIA  
ROUTE CLEARANCE  
VIA TO  
DIRECT YNKEE  
DIRECT GREKI N4128.8W07318.8,  
+LOAD NEW RTE TO JUDDS+ AFTER  
JUDDS CLEARED TO RKSI AS  
FILED,  
SKORR4.YNKEE, CLIMB VIA SID,  
EXPECT FL300 10 MIN AFT DP,  
DPFRQ 135.9, SQUAWK 7104,  
GROUND CONTROL 121.9 FOR TAXI,  
ADVISE GROUND YOU HAVE ATIS,  
----- KJFK SKORR4.YNKEE GREKI  
JUDDS ./ RKSI.  
----- RESPONSE 0243z ----  
ACCEPTED

Unfortunately, in this instance the crew **mis-interpreted their clearance as direct to the waypoint YNKEE**. This was further compounded by the issue above - when the new route was loaded, **their SID was dropped from the flight plan**.

When they got airborne, ATC immediately began asking why they weren't following the assigned SID - the result was a **clearance bust**. To their surprise, further down the clearance was indeed an assigned SID - the SKORR4. It was an understandable and easy miss.

- The FAA has published a new Safety Alert for CPDLC and partial route re-clearances.
- Make sure you load your full SID manually into the FMS after you receive a partial reroute message (UM79).
- Also, don't mistake these partial reroute messages as being cleared to fly directly to the waypoint (a direct clearance would be a UM74 message).
