Bad NOTAMS = Runway overruns in Hamburg

OPSGROUP Team
18 May, 2018

If you're headed to Hamburg, watch out. The runway is shortened, and the Notams are vague.

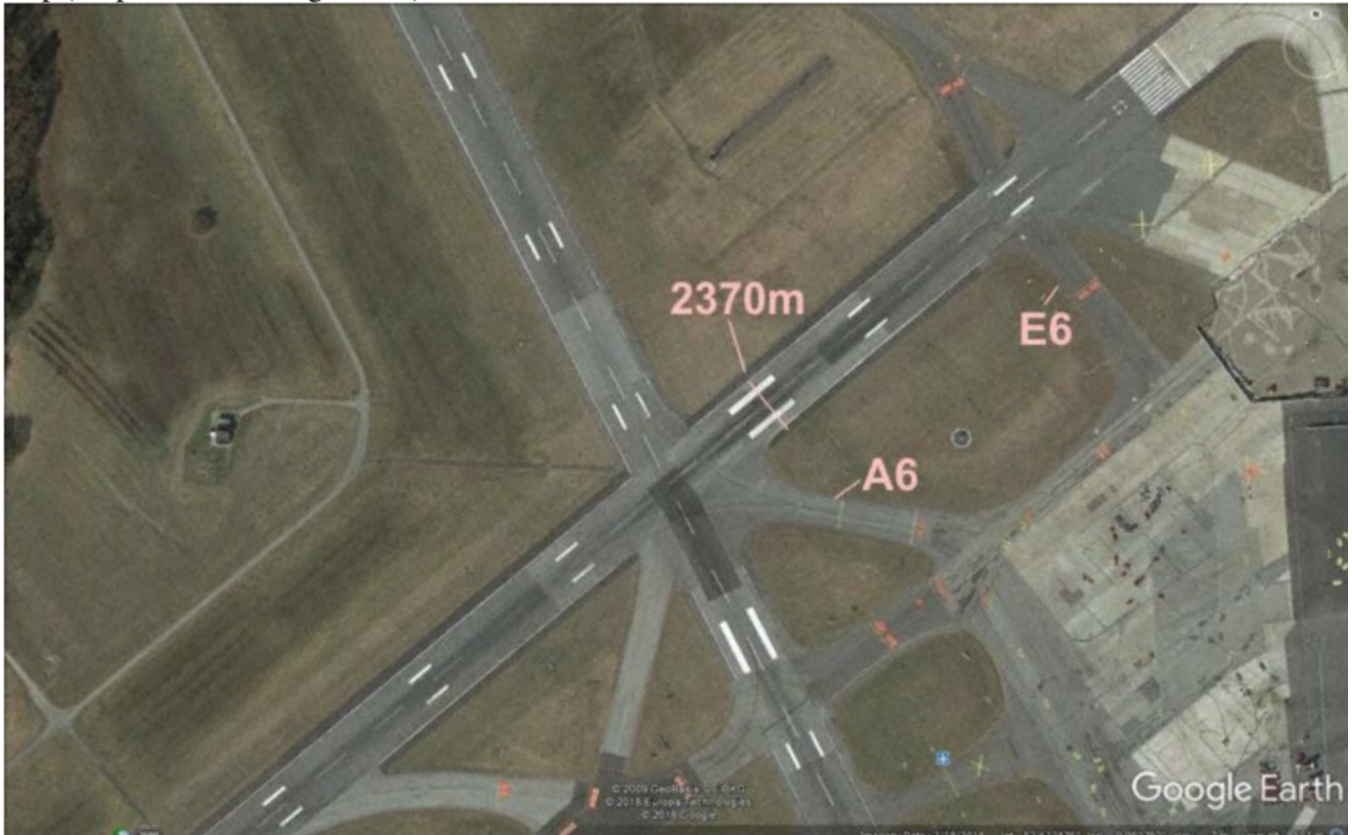
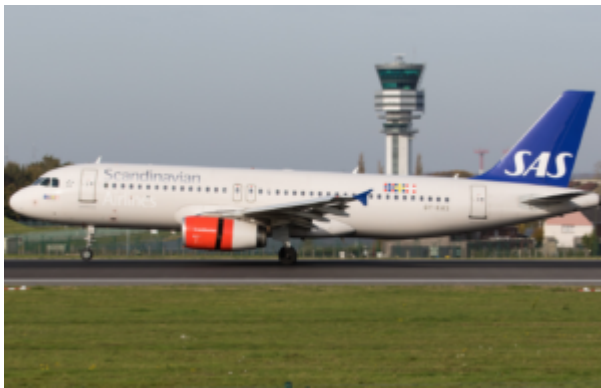
Map (Graphics: AVH/Google Earth):

Despite this, **both were unable to stop** before the last open exit (A6) and vacated further down the runway. Thankfully both resulted in no injury because all construction equipment was kept clear of, and beyond, taxiway E6.

RWY 05 IS SHORTER THAN USUAL DUE TO CONSTRUCTION WORK AT 23 END. REDUCED LANDING DISTANCE IS 2370M. LAST TAXIWAY OPEN FOR EXIT IS A6. CONSTRUCTION EQUIPMENT ON RUNWAY BEYOND TAXIWAY A6.

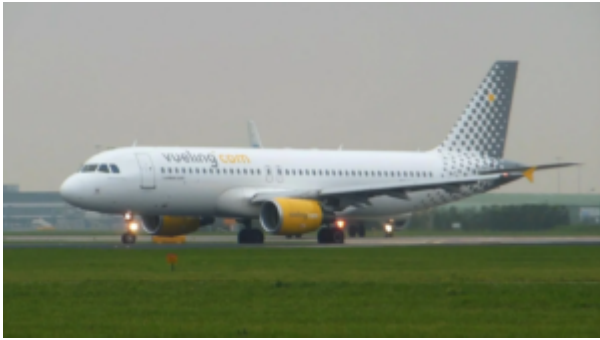
A2563/18 - RWY 05 CLSD EAST OF TWY A6. RWY 05 LDA 2370M. RWY 05 NON STANDARD TDZ AND AIMING POINT MARKINGS AT 400M FM THR ISO 300M. ADJUST LDG PERF ACCORDINGLY. 17 MAY 16:30 2018 UNTIL 23 MAY 21:00 2018. CREATED: 17 MAY 16:31 2018
