Bad NOTAMS = Runway overruns in Hamburg

OPSGROUP Team
18 May, 2018

If you're headed to Hamburg, watch out. The runway is shortened, and the Notams are vague.

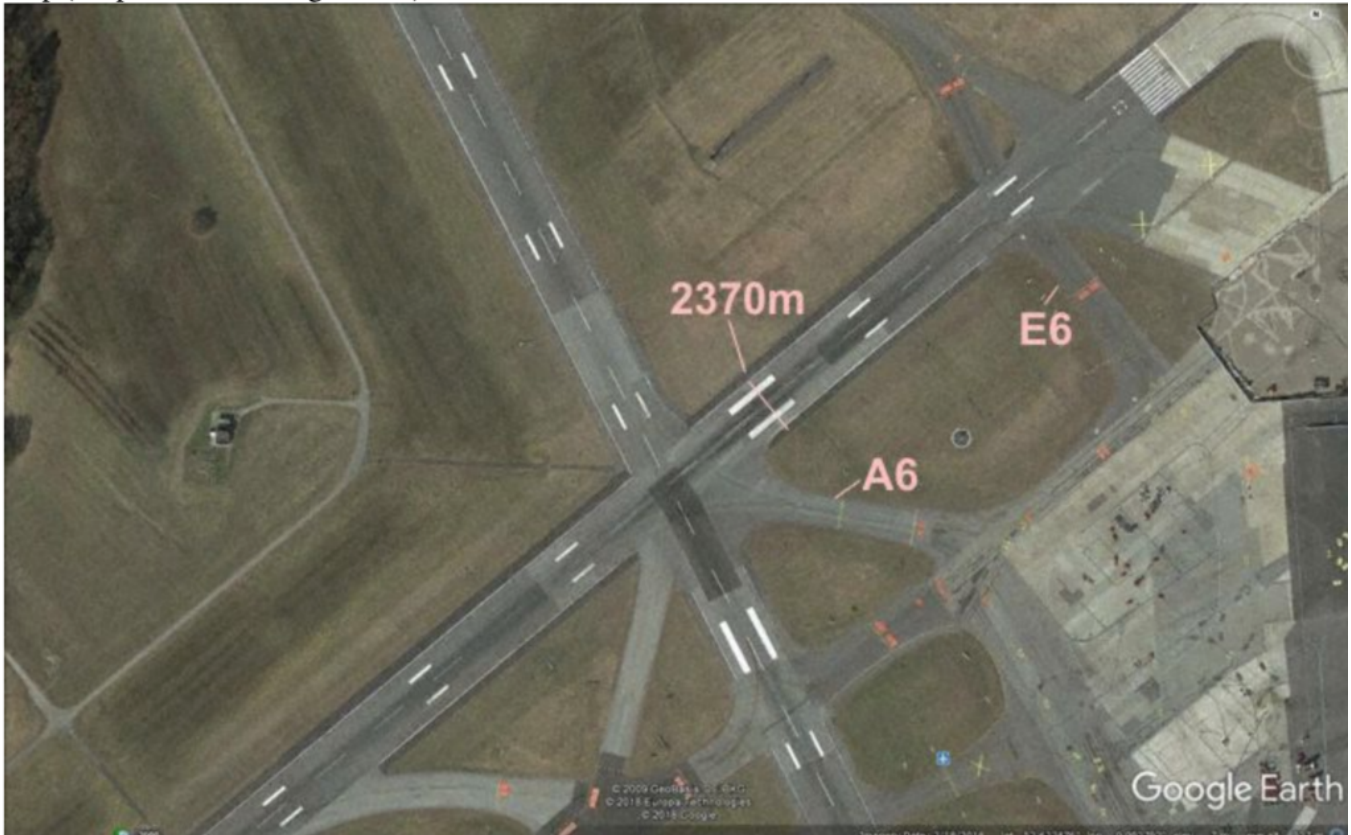
Map (Graphics: AVH/Google Earth):

Despite this, **both were unable to stop** before the last open exit (A6) and vacated further down the runway. Thankfully both resulted in no injury because all construction equipment was kept clear of, and beyond, taxiway E6.

A better NOTAM may have been:

RWY 05 IS SHORTER THAN USUAL DUE TO CONSTRUCTION WORK AT 23 END. REDUCED LANDING DISTANCE IS 2370M. LAST TAXIWAY OPEN FOR EXIT IS A6. CONSTRUCTION EQUIPMENT ON RUNWAY BEYOND TAXIWAY A6.

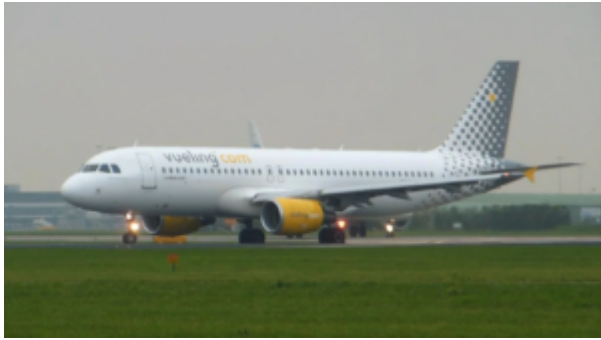
A2563/18 – RWY 05 CLSD EAST OF TWY A6. RWY 05 LDA 2370M. RWY 05 NON STANDARD TDZ AND AIMING POINT MARKINGS AT 400M FM THR ISO 300M. ADJUST LDG PERF ACCORDINGLY. 17 MAY 16:30 2018 UNTIL 23 MAY 21:00 2018. CREATED: 17 MAY 16:31 2018
