Check your checklist! Lessons from fatal King Air accident in Melbourne

OPSGROUP Team
25 September, 2018

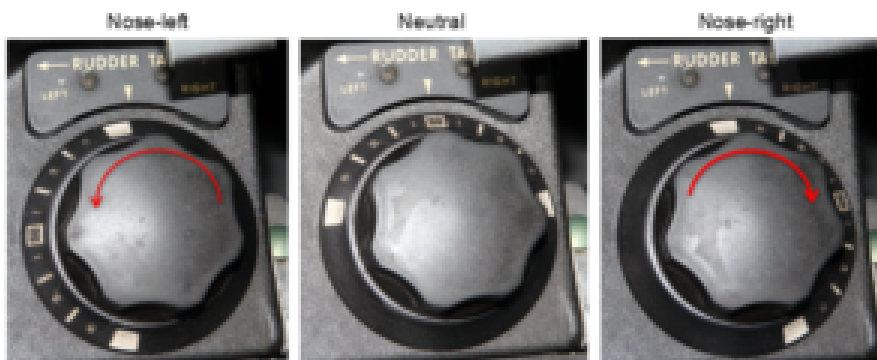
A King Air flight simulator was used to recreate the event as part of the ATSB investigation.

The pilot who performed the flight simulator test commented that:

*The yaw on take-off was manageable but at the limit of any normal control input. Should have rejected the take-off. After take-off the aircraft was manageable but challenging up to about 140 knots at which time because of aerodynamic flow around the rudder it **became uncontrollable.** Your leg will give out and then you will lose control. **It would take an exceptional human to fly the aircraft for any length of time in this condition.** The exercise was repeated 3 times with the same result each time. Bear in mind I had knowledge of the event before performing the take-offs.*

The pilot also stated that it could be possible for a pilot to misinterpret the yaw as being caused by an engine power loss rather than from a mis-set rudder trim.
