Sydney Near Miss!

Chris Shieff 14 December, 2022

On November 14, a **major runway incursion** was narrowly avoided involving an Airbus A380 and Boeing 737. It sounds like the incident may have been caused by an ATC error – although an ATSB investigation is still underway.

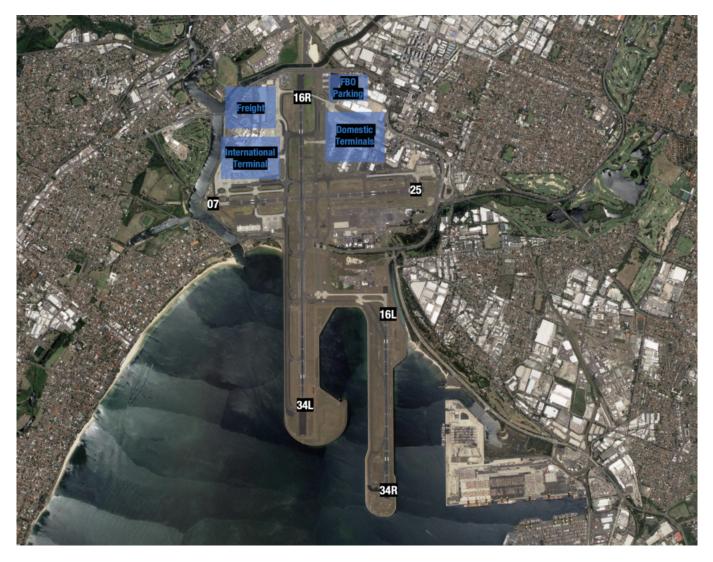
Sydney's runway layout is complex. There are three runways – two parallel ones (16/34 LR) and another runway that runs perpendicular to them (07/25). The airport itself sits perched on the edge of Botany Bay, with the parallel runways extending well out over water. And all terminals and FBOs are found clustered together on the northern side of the airport, near the 16R threshold.

Which means taxis to/from all the other runways are **lengthy and potentially confusing**. And during those taxis, **almost every aircraft will need to cross a runway**. Often twice.

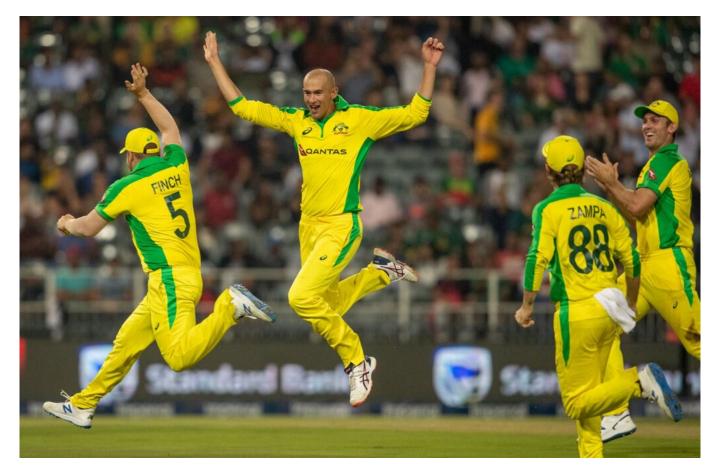
A good place to start is this. **To cross a runway in Sydney always remember the 'hat-trick.'** You know all about cricket right? Well if you're headed to Australia, this phrase can also be used to impress Aussies at the bar over a cold Fosters (disclaimer: no one drinks it there, and whatever you do never call a prawn a shrimp). It means three successes of the same kind. Or in other words: **a set of three good things.**

So, there are three things that you'll need:

- A clearance from ATC
- Confirmation that the stop bar is out
- Runway is visually clear out both sides

If any of them are missing (or uncertain), **do not enter the runway.**

Remember the hat-trick every time you cross a runway.

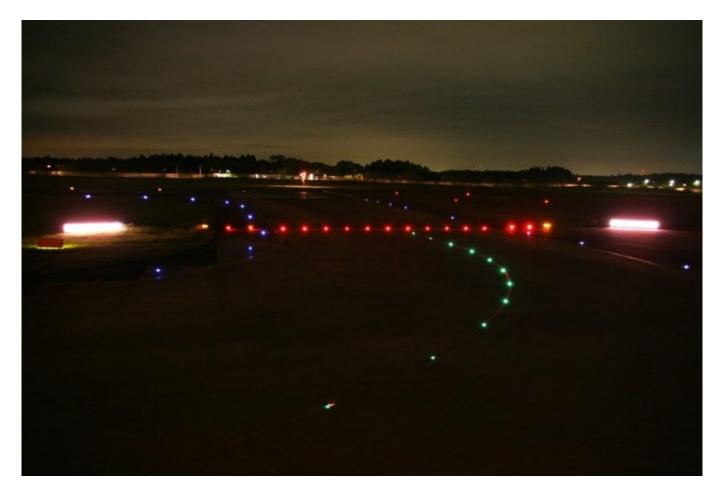
We're cleared, but the stop bar is still lit...

Yep you guessed it, stop. And this happens really often. You'll need to ask ATC to turn it off. Never, ever cross a lit stop bar.

But didn't he say we were cleared?
