# Heat Damage in Nice: When APU Rules Damage Aircraft

OPSGROUP Team  
16 July, 2025

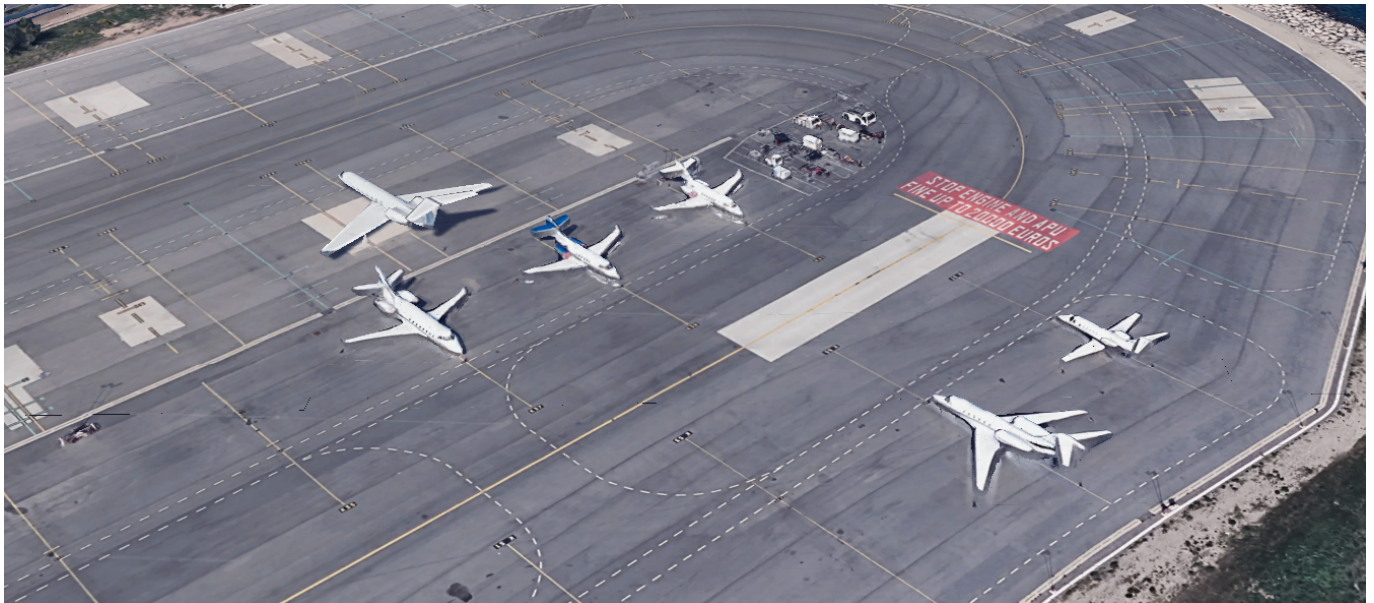
- *Arriving flights* must stop on a designated line labelled 'STOP ENGINE AND APU.' From there towing to your parking spot is mandatory.
- *Departing flights* must be towed to start-up stands fitted with 400Hz/28v ground power units, along with air. APU usage is limited to 10mins prior to TSAT (Target Start-up Approval Time).

The Kilo Apron at LFMN

Private jet flights at LFMN primarily use the 'Kilo Apron.' This is the designated parking area for BizAv close to FBO facilities.

The rules for APU usage are found under the airport briefing in the French AIP. **Specific guidelines apply to the Kilo Apron:**
