Heat Damage in Nice: When APU Rules Damage Aircraft

OPSGROUP Team
16 July, 2025

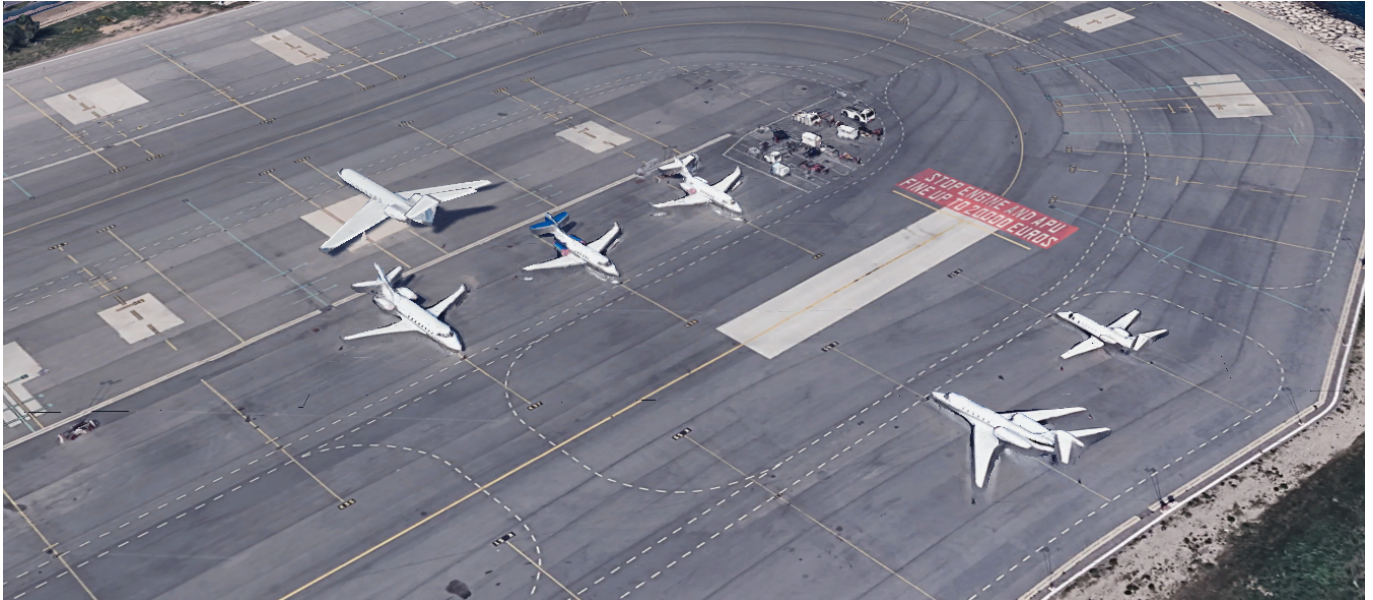
The Kilo Apron at LFMN

Private jet flights at LFMN primarily use the 'Kilo Apron.' This is the designated parking area for BizAv close to FBO facilities.

- *Arriving flights* must stop on a designated line labelled 'STOP ENGINE AND APU.' From there towing to your parking spot is mandatory.
- *Departing flights* must be towed to start-up stands fitted with 400Hz/28v ground power units, along with air. APU usage is limited to 10mins prior to TSAT (Target Start-up Approval Time).
