# No Room for Error - GNE's and the North Atlantic

Chris Shieff  
11 December, 2019

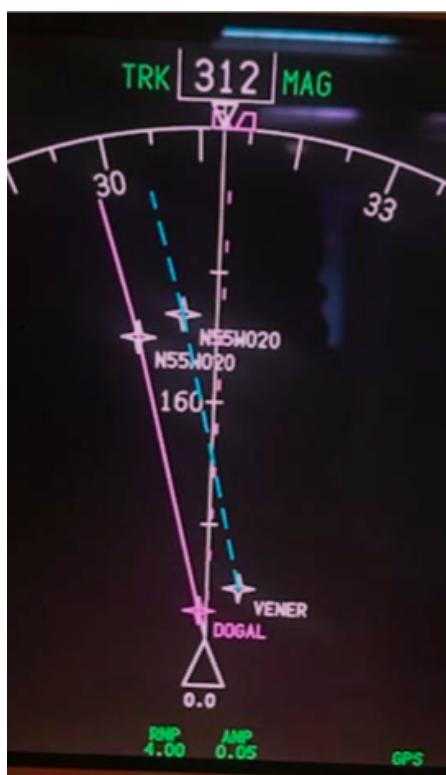
For the last few years, use of half degrees of separation has been on the rise in an attempt to enhance airspace efficiency. But on flight displays units that only show 7 digits, these half degree coordinates are misleadingly displayed as full coordinates. For instance, the half coordinate  $N55^{\circ}30' W020^{\circ}$  will display as  $N55^{\circ}W020^{\circ}$  (see image below, which shows identical waypoint labels for points separated by half a degree!). In this case, it is imperative to view the expanded version of coordinates (degrees *and* minutes).
